A Collaborative Approach to Historic Concrete Repair

ACI members share knowledge at APT concrete preservation workshop

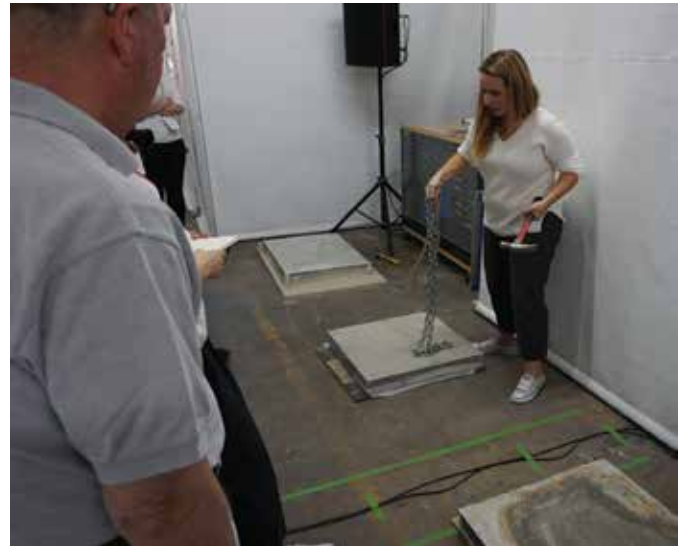
Ann Harrer, WJE, demonstrates NDT methods on concrete samples

Deterioration can be material-related, corrosion-related, or both; it can also result from original construction defects. The type and location of deterioration provide baseline data to help determine the appropriate repair design. With NDT, at least two or three methods should be included—whether that be sounding, crack mapping using crack gauges, or locating embedded reinforcing steel. Ground-penetrating radar (GPR), impact-echo, and rebound hammer testing are other options. While there can be added cost with exploratory openings, this option is very useful in providing information on hidden conditions and to confirm findings of NDT assessment.

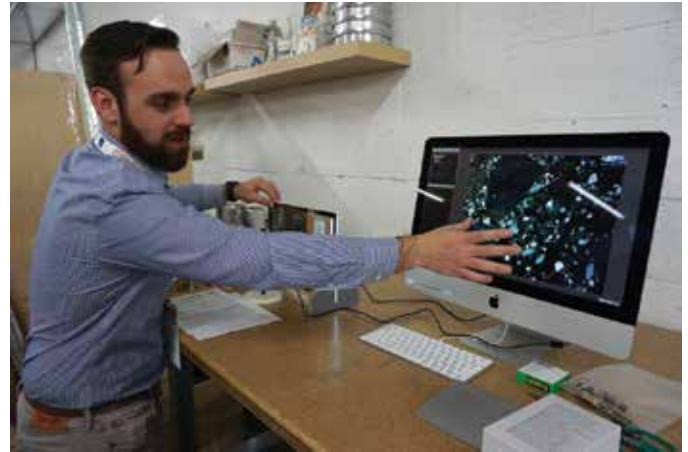
George Reo, WJE, applies a polarizing filter to a petrographic sample to view aggregate color

Petrography is a useful tool in the repair of architectural concrete to identify distress mechanisms and predict future performance. From data collected in the field, when the features are seen under the microscope, interpretations can be made about how things got that way and characteristics of the concrete can be understood.

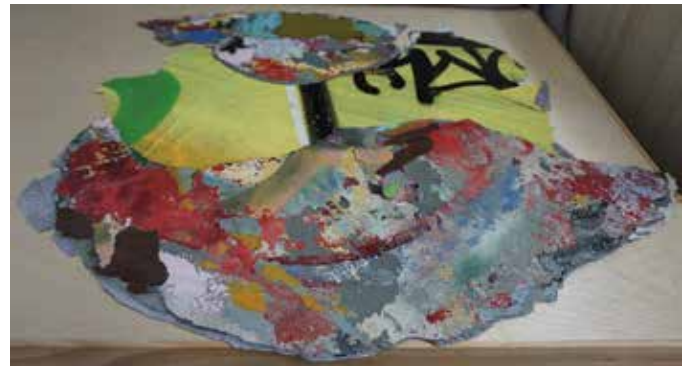
Sample of graffiti and paint layers from the Miami Marine Stadium

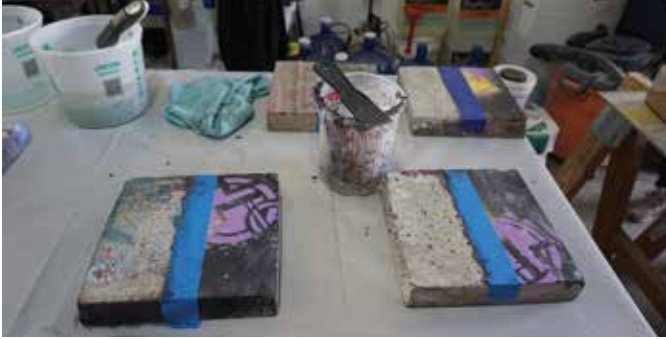
Comparison of paint strippers used to remove coatings or graffiti from concrete

In 2017, cleaning protocols were evaluated to take the structure back to its original smooth surfaces, removing up to 200 layers of paint. Trial samples and mockups were performed for a range of systems, and after testing, dry ice blasting and eco-friendly paint strippers were chosen. Products with the least amount of environmental impact were selected. The dry ice method did not appear to damage the surface and worked very quickly to remove thick layers. The sheer volume of paint and painted surfaces was a challenge.

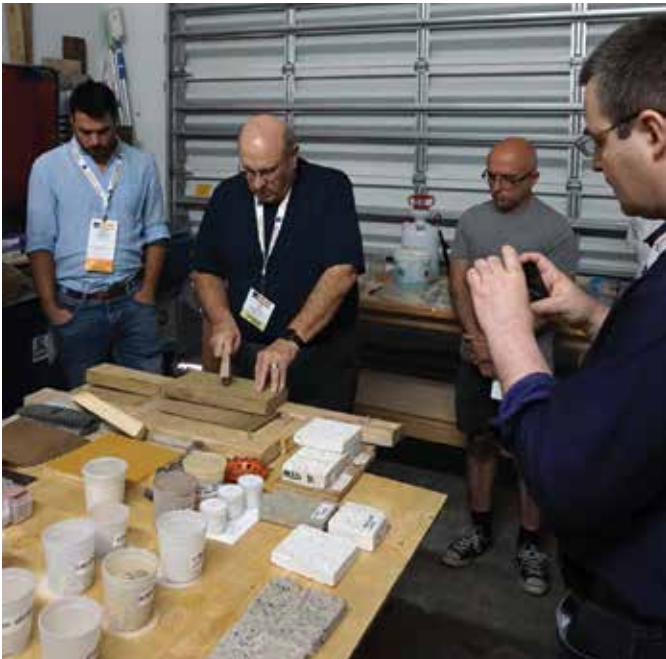
Bob Joyce, Quality Restorations, Inc., demonstrates matching and surface treatments
